## Holiday Inn Express Case Study

**Application:** Whole building protection with Scaleton

US Case Study

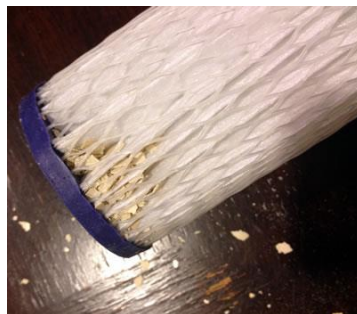
Scale in 3" Copper  
Feed Pipe

**The Challenge:** This Holiday Inn Express, a 4 year old 73 room facility, was put into operation with no water treatment in place. When scale built up and fouled the mixing valve in the utility room, the facility was shut down completely with no water supply. A service contractor was called in. During the service and replacement of the mixing valve, scale broke loose and traveled throughout the hotel, blocking faucets and fixtures and causing a major maintenance headache. Customer satisfaction also suffered due to the unpredictable interruption of water supply. Extra clean-outs were added in an effort to flush out chunks of scale and a sediment filter was installed ahead of the washing machines to protect them from scale (see above).
