# Scale Prevention for Compressors

**Maintaining Efficiency and Reducing Costs**

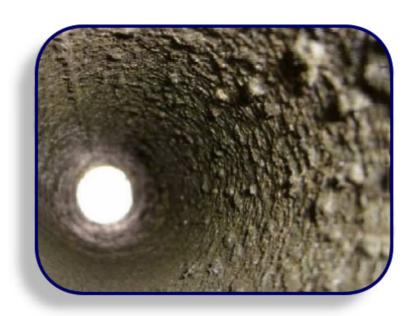
Scale formation inside compressors is caused by the deposition of calcium carbonate from hard water that is used to cool the compressor.

As the water draws heat from inside the compressor a thick crust of scale builds up inside the water pipes. The scale insulates the piping decreasing the efficiency of the heat exchange.

As the scale deposition increases the pipe capacity decreases reducing the amount of water supplied to the compressor and can even eventually lead to pipe blockages.

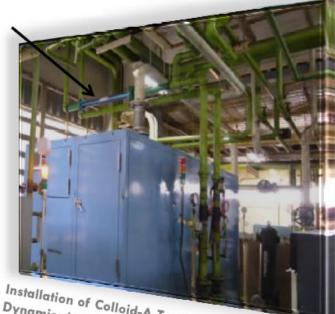
Installation of Colloid-A-Tron manufactured by Fluid Compressor

Compared to traditional methods of manual removal of scale and chemical dosing systems Fluid Dynamics equipment is very simple to install and operate. Our equipment comes in the form of a tubular unit, the diameter of which depends on the flow. The unit is installed in the cooling circuit replacing a small section of pipe leading to the compressor. Once installed there's no requirement for earthing or bonding, no need for a power supply and no water is wasted during our treatment process.

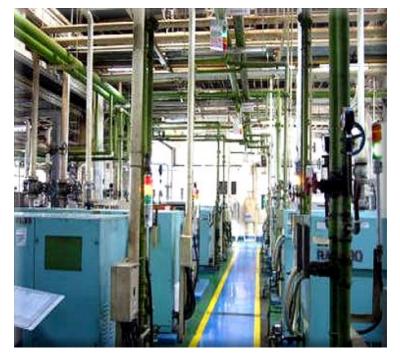
Compressors & Air Dryers at Thai Honda

A series of 220 KW air compressors and air dryers generating compressed air which is used to power various equipment throughout the plant.

Due to the energy produced the equipment generates a large amount of heat and cooling water is continuously circulated through the equipment to control the temperature.

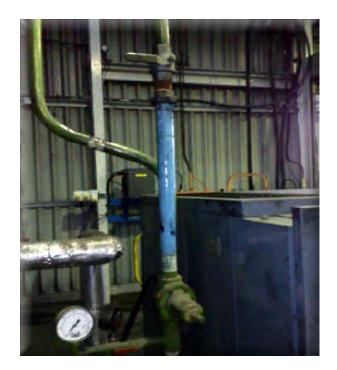
Prior to installing Colloid-A-Tron's in the compressor circuits, the compressors required cleaning twice every month to remove the deposition of scale. Since 1980 a number of units have been installed due to the success of keeping the equipment totally scale free. The first unit installed was a 3" Colloid-A-Tron followed by a 11/2" Colloid-A-Tron the following year. In 1990 a further three units were installed including 2 x 1½", 1 x 1" and 1 x 1¼ Colloid-A-Tron units. The most recent unit commissioned in 2008 was a 4" Colloid-A-Tron which is testament to the success of the treatment on the compressors. Since installation of the first unit not a single compressor has required shutdown for cleaning. One compressor was run as a trial with no treatment for a short period and within six weeks the compressor required a shut down for de-scaling.

**Columbian Chemical Installation**
