Tetra Pack downtime almost eliminated

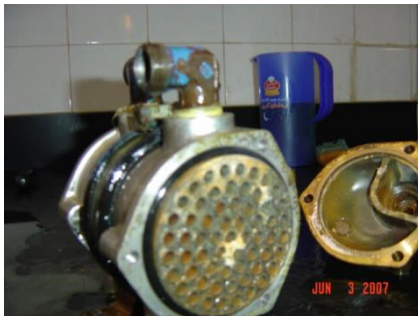
(above left image shows heat exchanger following 1300 hours of use).

The customers' input was that from now on they do not need to clean the heat exchanger every 500 hours but can extend the time between cleans. The spot shown in the photo is not scale but dirt collected at the surface as this chilled water is suffering from rust and dust carried within the water. The improvement in performance of the heat exchanger, combined with the fact that the cleaning frequency has been reduced (extending the life of the heat exchanger) has made Colloid-A-Tron an excellent investment.

Inspections were taken every 500 hours. The first 500 hours revealed that the heat exchanger was as clean as when it was last serviced. The second inspection after a further 500 hours showed still no hard scale. It was left to run for a further 300 hours where the net inspection showed some small sludge like deposits that could easily be removed with a toothbrush in a matter of seconds.

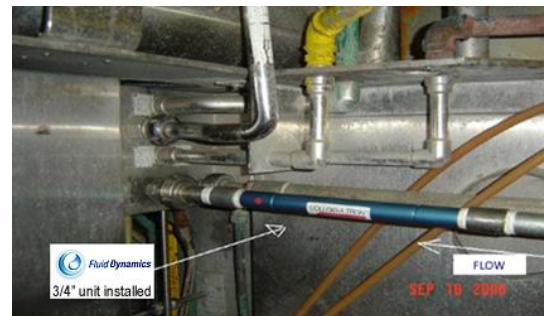
A 3/4" (19mm) Colloid-A-Tron was installed on the feed line (pictured below right), to prevent the hard scale from accumulating though its special alloy treatment.
